Building the Dome

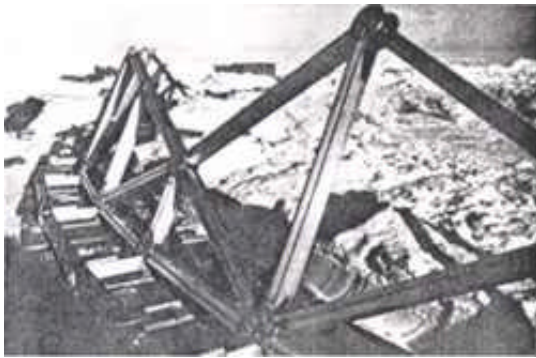
Here is a view of the early construction of the dome base ring from the 1971-72 season (*Navy photo, Antarctic Journal (AJ) 3/72*). Very little of the ring actually got built during the first season.

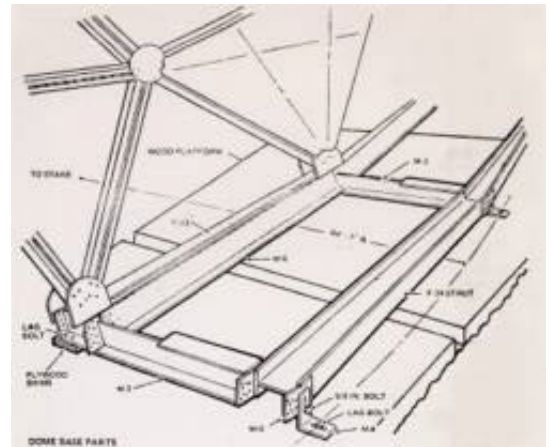
This diagram from the TEMCOR dome erection manual shows the details of the foundation base ring. The differential settlement of the timber pads underneath this foundation caused some of the aluminum nodes and base ring beams to break eventually, these were repaired in 1989-90.

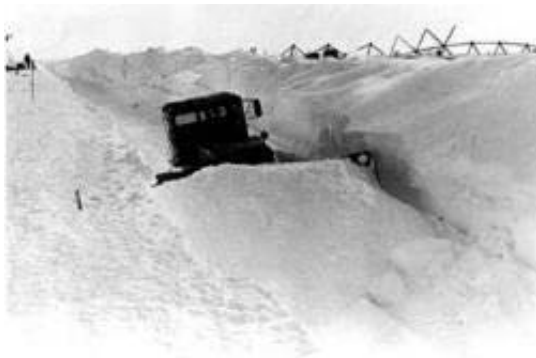
The photo at left (this and the next 2 photos courtesy Bob Nyden from a 72-73 cruisebook) shows early construction of the dome ring, while excavation for the utilidor is also proceeding.

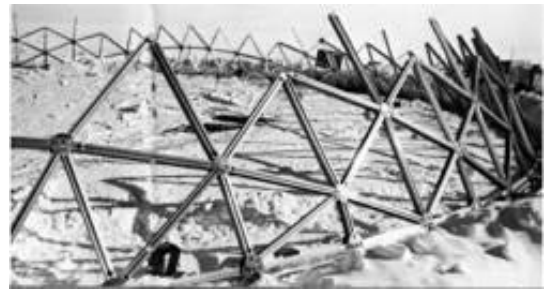
The lower portion of the ring is mostly in place

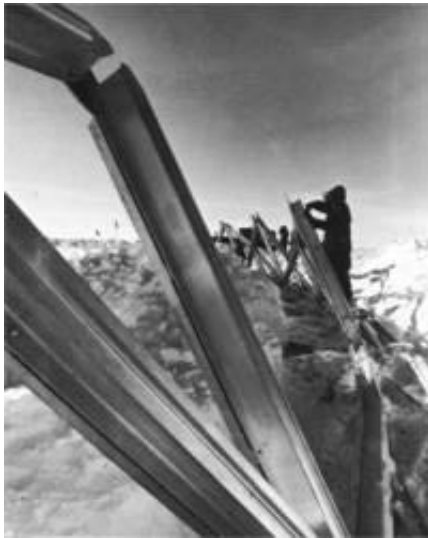
Seabees assemble the lower portions of the dome.

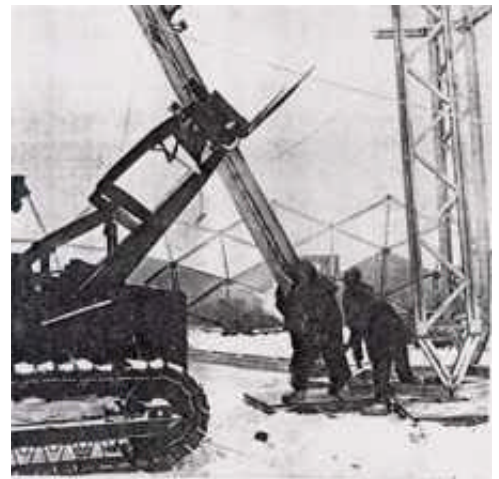
Erection of the dome required scaffold towers around the edges to support the lower portion of the dome ring until the entire geodesic structure was completed. The central portion was erected on the surface, and slowly raised on a central scaffold tower. At left you see the tower being erected (*Navy photo, AJ 7/73*)

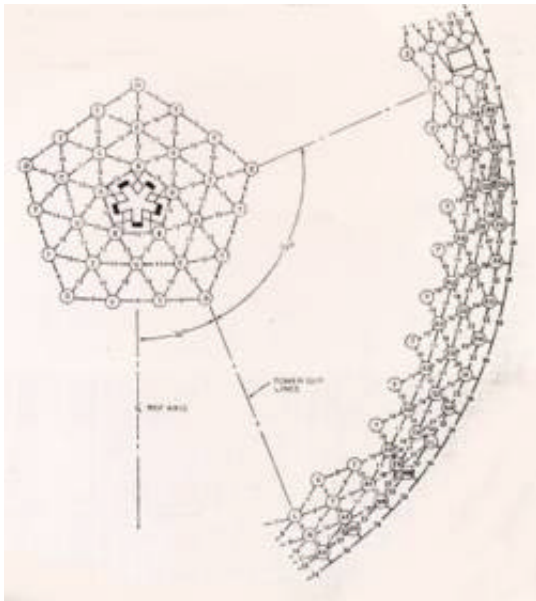
This page from the TEMCOR manual shows the central tower and the initial assembly of the upper portion of the dome. The 5-legged tower had 10 winches which attached to the upper portion, after each ring was added the assembly was pulled up and the next ring installed.

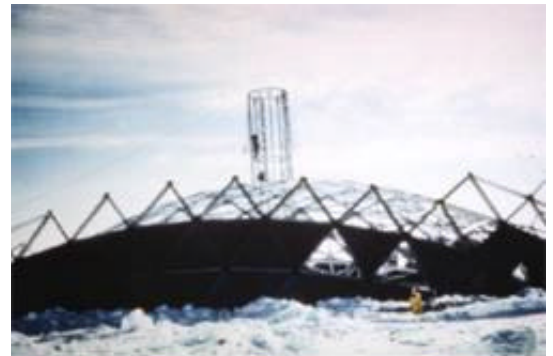
This view from outside the dome shows the central tower supporting the skeleton of the upper portion of the dome, behind the lower portion which has some of the skin panels installed. (this and the next photo from NSF courtesy Jerry Marty)

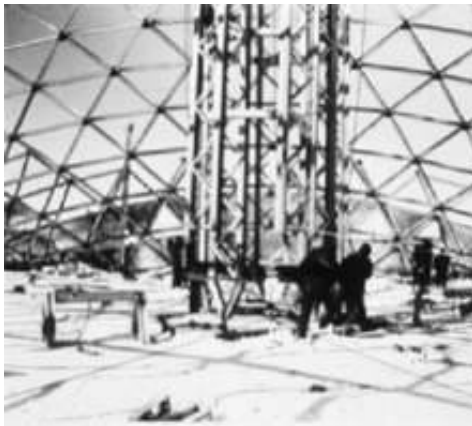
At left, a closer view of the tower, as the raising of the central portion of the dome is underway.

portions of it will be erected at 10 equally spaced points around the edges of the upper section, to lift it up to join the lower portion of the dome ring, which is visible in the background.

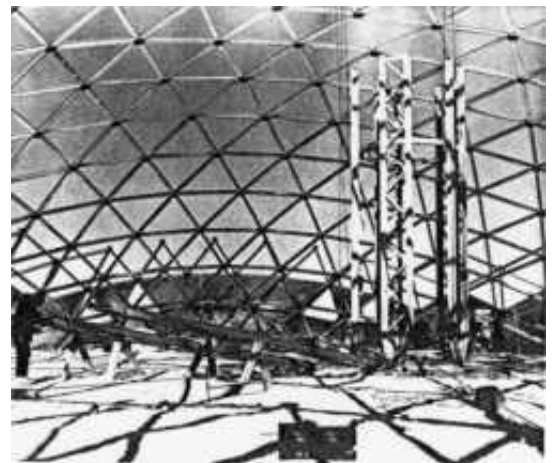
At right, later in the season (Navy photo, AJ 7/73) the dome upper portion assembly has been completed, with its outer edge resting on the snow surface. Here the central tower is being dismantled;

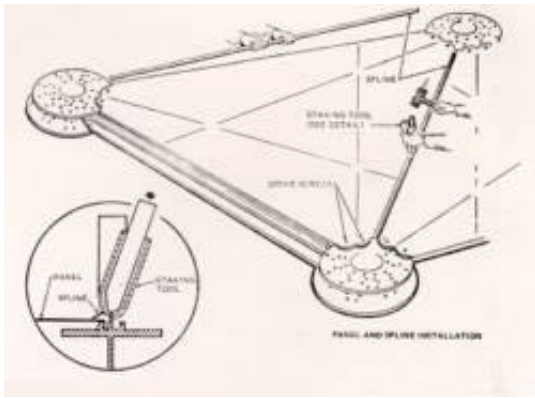
This page from the TEMCOR manual shows how the sheet aluminum dome panels are installed. As you can see, removing the panels is rather difficult (as we found out in 1989-90; also all of the fasteners which connect the nodes (circular pieces) to the beams, are "Huck" fasteners, or aluminum rivet-like connectors which must be ground off to remove. Some of the reasons why nondestructive removal of the dome for reuse elsewhere might be a bit labor intensive.

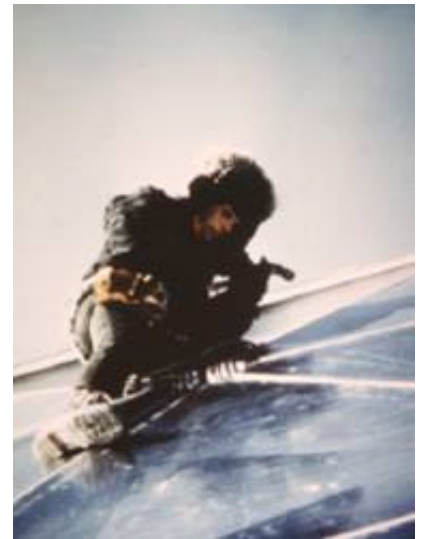
The last dome beam was installed on 4 January 1973. At left, the dome is fully erected, with panels being installed. The machine parked in the right foreground is one of those Peter Snow Millers (photo from Bob Nyden).

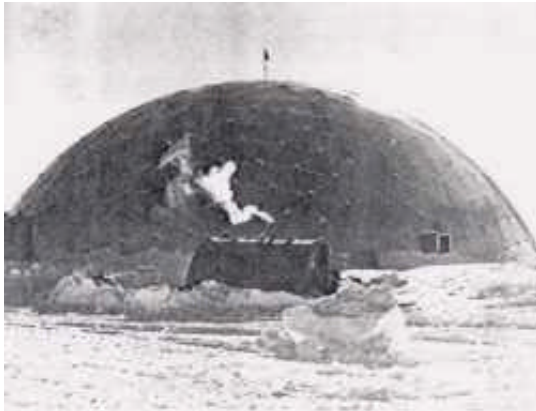
Here is a construction Jamesway west of the newly completed dome. The emergency exit is visible to the right. *US Navy photo, AJ 7/73*

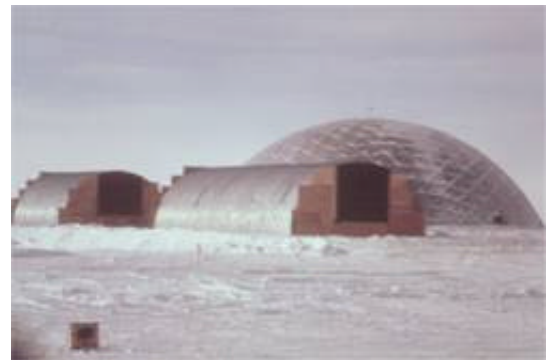
At right, the partially complete power plant and garage arches at the end of the 1972-73 season, boarded up for the winter

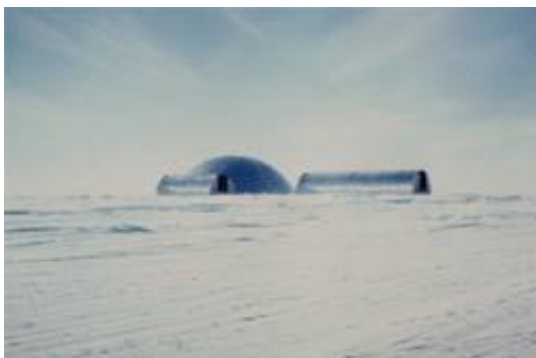
Another view of the 2 partially completed arches at the end of the season.
