There's no place like dome

By *Kristan Hutchison*
Sun staff

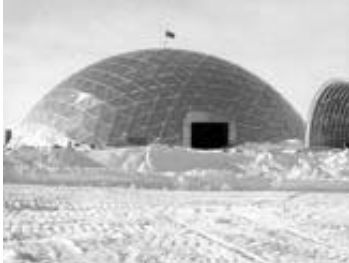
That's exactly what they got, a 65-foot-tall aluminum dome reflecting back sun or moonlight, depending on the season. The first, and in many ways only, structure of its kind, the South Pole dome outlasted its designers initial estimates by 20 years.

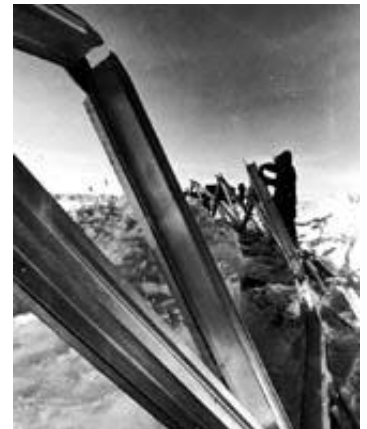
The snow kept piling up. In 1989 someone heard a loud bang in the dome and Curtis was called down again. He found the tension ring holding the dome together had snapped in two places under the strain of the foundation sagging and twisting.

"Normally that would be a disaster for a dome, but this time it wasn't a problem because it was trapped in all the ice that was around it," Curtis said.

Curtis came down again in 1990 with newly manufactured parts and 10 hand-operated jacks. Five of the jacks broke by the end as they lifted and evened out the dome.
